# Invisible

The Fascination of Conservation

THIS BROCHURE WAS PRODUCED BY GESINA AMRHEIN, HENRIETTE HENNING, SASKIA HÖLTKEN AND NINA MEINHOLD AS PART OF A PROJECT OF THE STUDY PROGRAMME "EUROPEAN CULTURAL HERITAGE" AT THE EUROPEAN UNIVERSITY VIADRINA IN FRANKFURT (ODER).

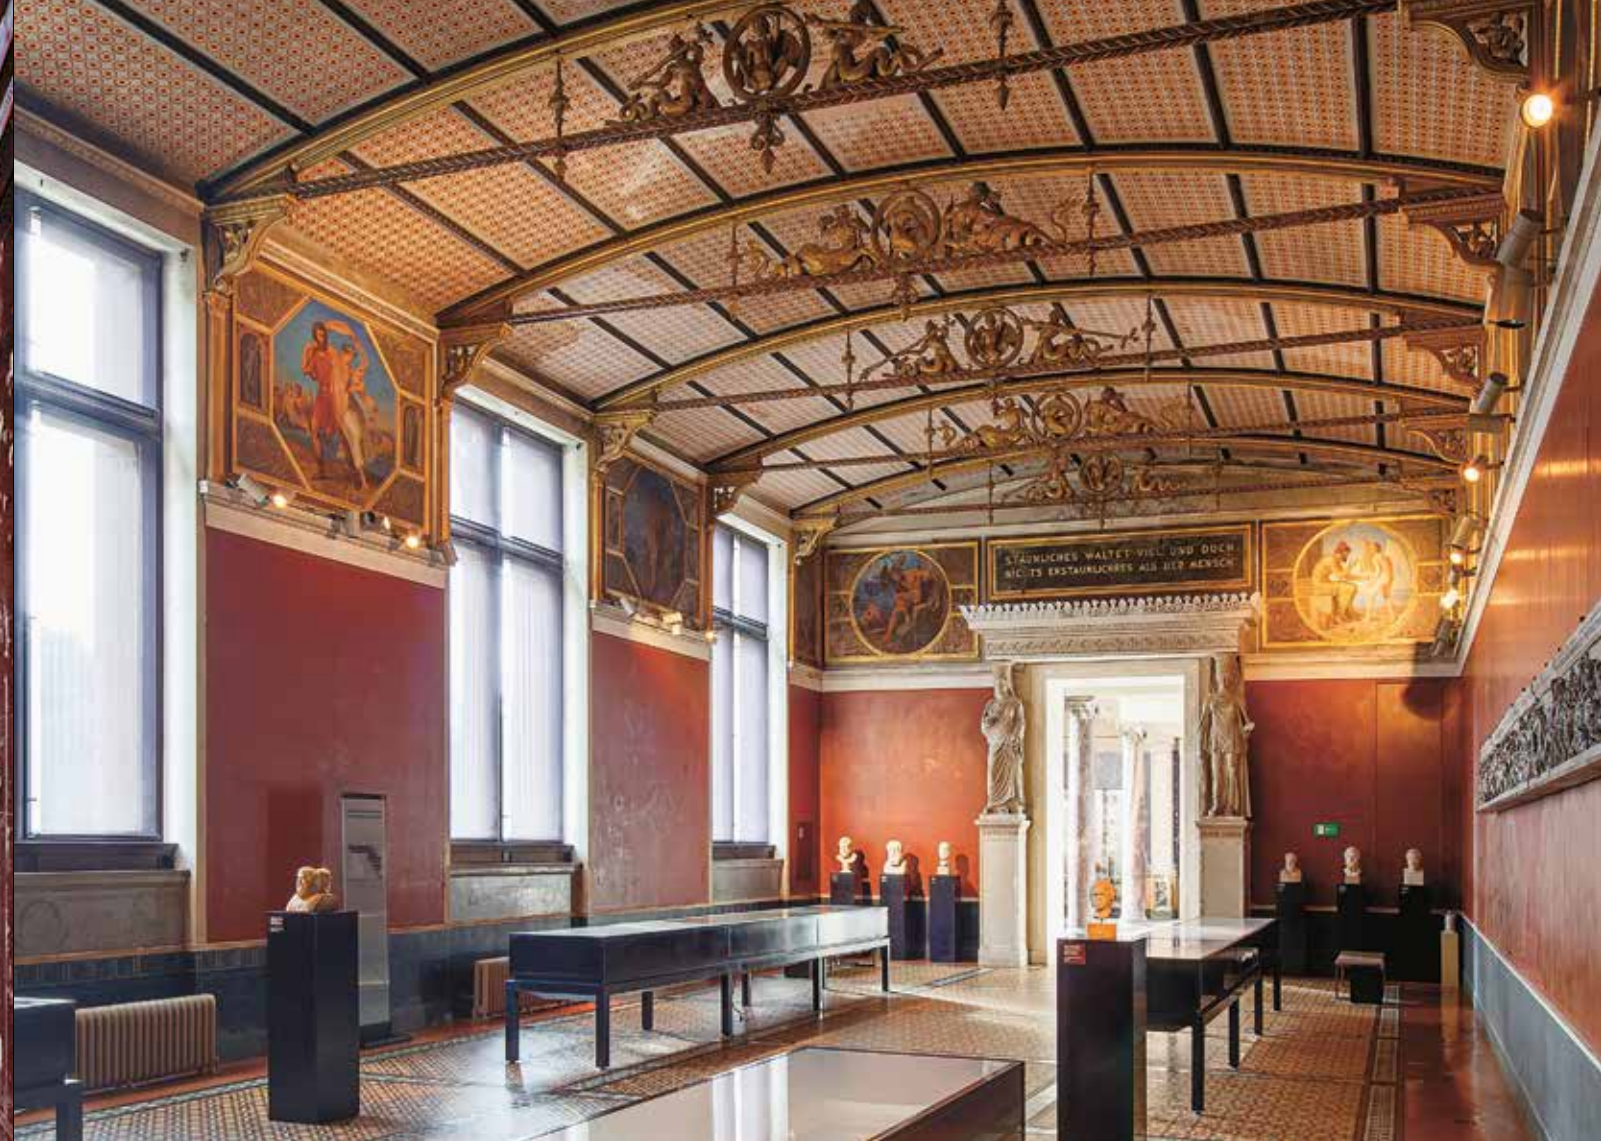
Niobid Hall

Nowadays, the **Niobid Hall** remains impressive in its historical splendor. This is mainly due to relatively minor wartime damage, the extensively preserved decorations on the walls and ceiling, and the restoration that left the hall in its authenticity. All the measures have been made recognizable, so the history of the place can still be sensed today. To keep the modern

additions from taking center stage, conservators use our eye's ability to complement and unify things in context – even if they look different when viewed individually.

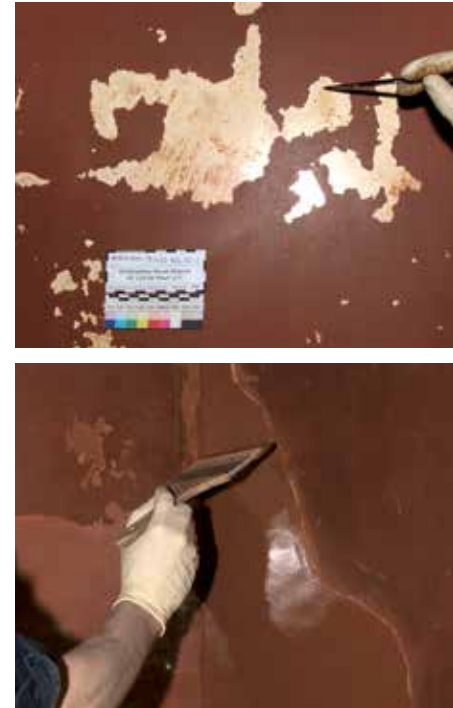
Inpainting is an example of such a restoration technique. We would like to illustrate to you through the colored wall and ceiling paintings that such a procedure can be carried out in many different ways. Most of the surface of the wall appears in a uniform shade of red. However, before the restoration, they were not so homogeneous. If you step closer to the windowless longitudinal wall, you can see transitions between the historical and the newly added coats of paint. New paint was also applied in a shade of red, but it has a slightly different hue. When we view them as a whole, our eyes complement these differences to create a uniform surface, so the wall appears relatively undamaged. This technique is called Normalretusche. It is used to harmonize heterogeneous surfaces and helps make the original concept of design recognizable again.

The term **inpainting** is used in restoration to describe the color tinting of imperfections. The purpose of inpainting is to harmonize the differences in appearance so that the original design becomes visible once more. Inpainting can be carried out in different ways using different techniques, depending on the object and context.

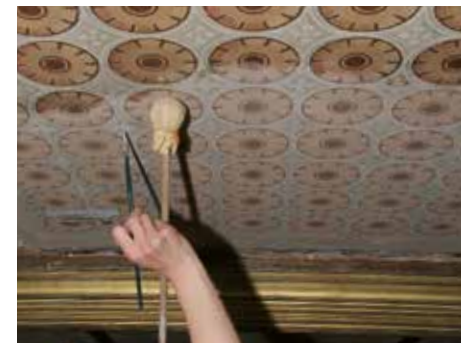
If you take a look up at the ceiling, another type of inpainting becomes visible. By use of a special stencil technique, the conservators have restored the flower-like circular ornaments by using a so-called "Totalretusche" method, or an exact color match.

The paint application consists of several layers. For each layer, the conservators had to make a stencil based on the existing painting, which they then used to recompose the ornaments. Finally, they applied the highlights, contours, and dots freehand with a brush. For the retouched areas, they chose lighter colors in a slightly grayish tone, so that there is no great contrast between old and new, but our eye can distinguish them despite the great distance.

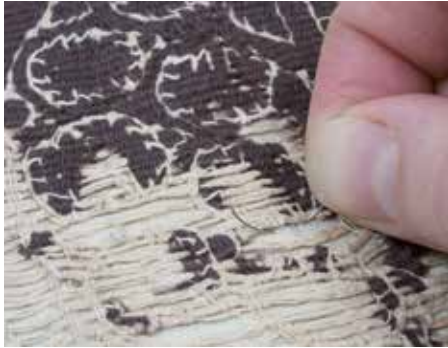
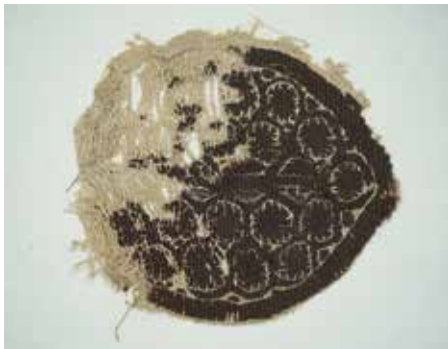
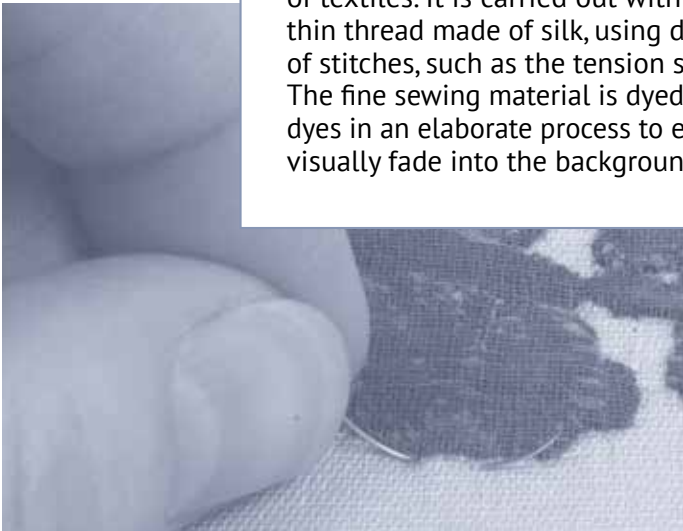
If you turn to the small display case on the window wall, you can see an archaeological object made from an extremely delicate organic material that has been preserved under very special circumstances. This textile comes from Egypt, probably from a tomb. It has been preserved in the soil over centuries in the dry desert climate, which is an archaeological exception.

The dry soil conditions protected the textile from sunlight and fluctuations in humidity, allowing it to maintain its structure and color intensity. In order to preserve the fragile object and make it accessible to the public, conservators applied a preservation technique using needle and thread, known as the “sewing preservation technique”. A supporting base must first be created, on which the fragment is aligned and fixed with very fine and elastic silk threads. There are various types of stitches for which the conservators use extremely thin and small circular needles that were originally intended for surgical purposes. During this delicate work, they stitch marginal and defective areas of the fabric to prevent further damage to the intact areas and to avoid further mechanical stress. As a result, further material loss is prevented and the damaged fabric is stabilized and strengthened at the same time.

The **sewing stabilization technique** is used for the preservation of textiles. It is carried out with fine circular needles and thin thread made of silk, using different techniques and types of stitches, such as the tension stitch or the running stitch. The fine sewing material is dyed in advance with special textile dyes in an elaborate process to ensure that the fine silk threads visually fade into the background.

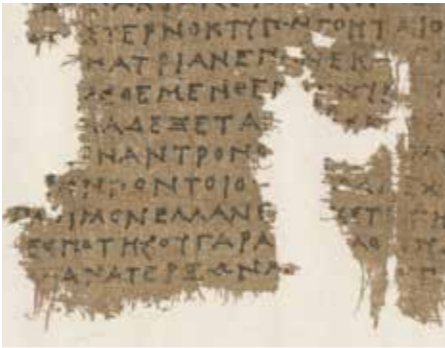
You might have already noticed that the Niobid Hall is relatively dark. Well, take a closer look at the papyri objects in the table show-cases. It is of paramount concern to protect these sensitive objects from light radiation. Material paper only lasts for a limited time. Strong and long-lasting illumination can cause severe damage to organic material, such as the papyri objects shown here. For this reason, the papyri are presented in special table showcases and only appear for a brief moment when you press one of the buttons. The consequences of light and radiation can be seen on the papyrus “Timotheos” in the first display case on the left next to the window if you press button number 1. In the center of this object is a slightly lighter-looking fragment with faded ink. These color changes occurred because the fragment was exposed at one point to strong light radiation for an extended period. The remaining fragments were protected in the dark depository, which is why they do not show such color changes. When the Museum was reopened on Museum Island, it was decided to show all fragments again together.

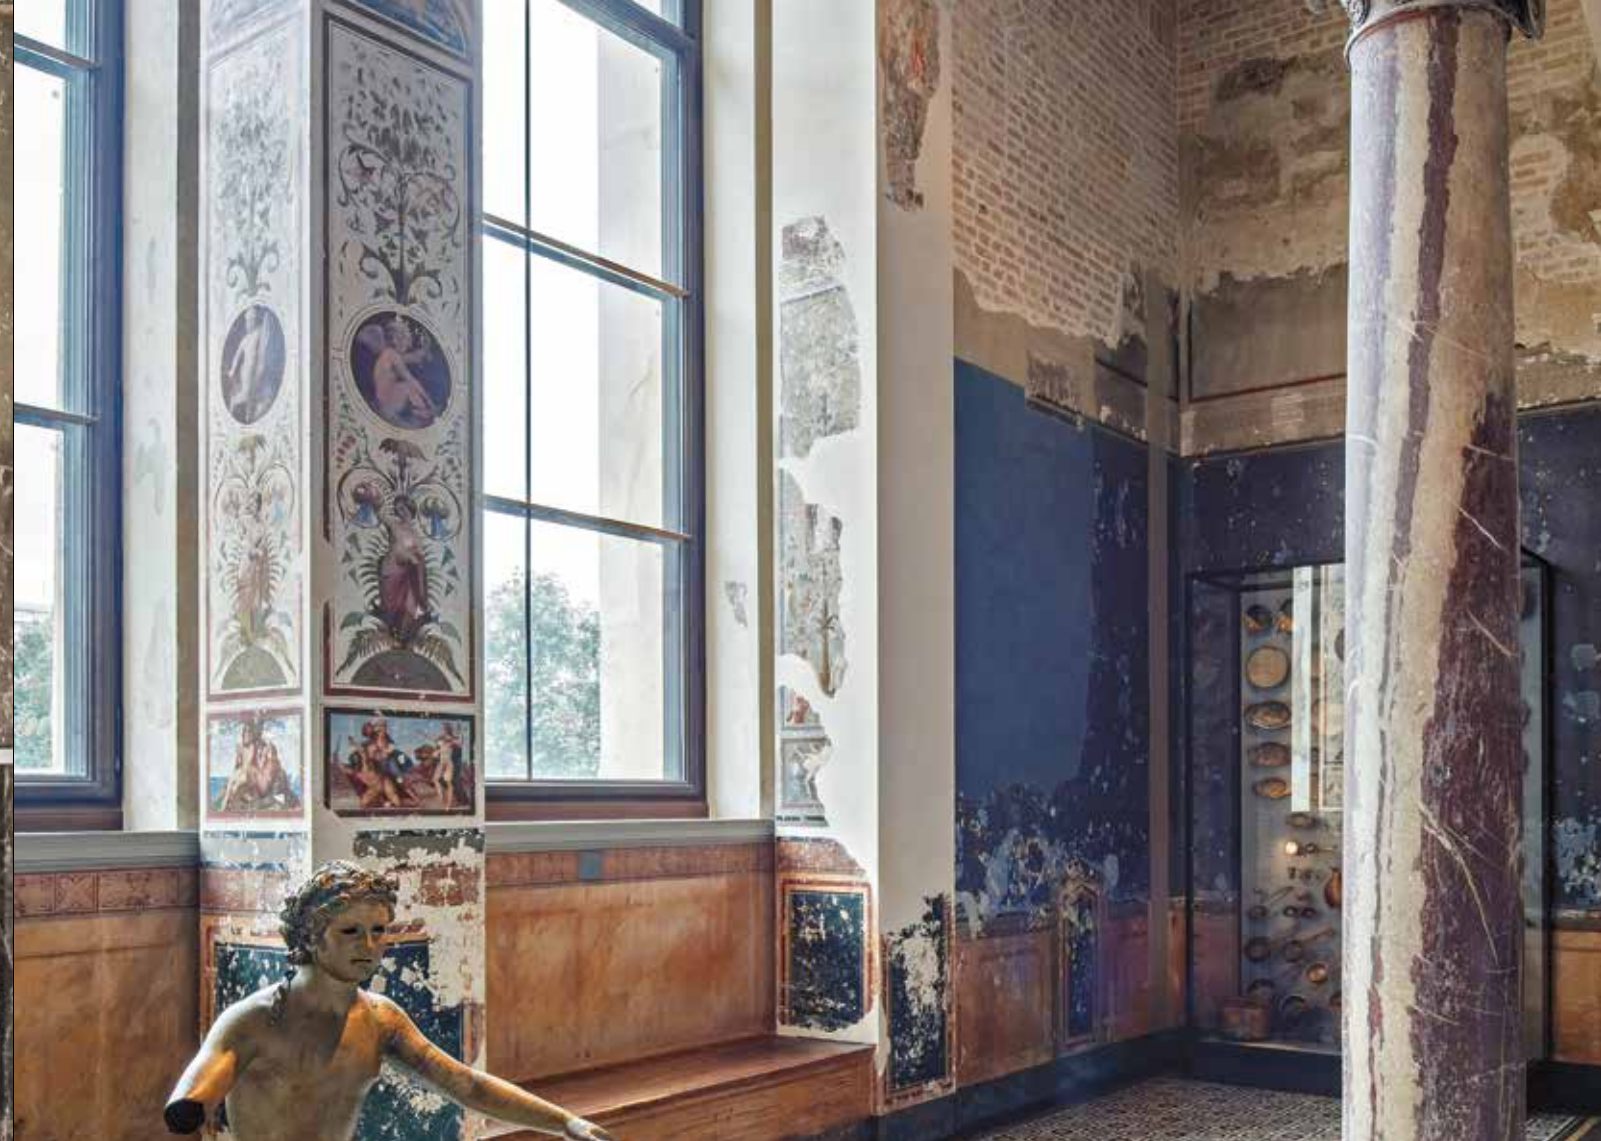
The **Bacchus Hall** has a completely different look than the Niobid Hall: it appears more dynamic in its spatial appearance. The wall's surface attracts our gaze because our eyes cannot adjust to the different contrasts and focus them into an overall picture. The room shows us its turbulent history: During the Second World War, the roof was destroyed and exposed to the

elements for many years. We wanted to present different conservation measures on the wall and plaster surfaces, which focused specifically on the preservation of the historical substance.

The wall plasters that you see here in the room were hollow and no longer connected to the masonry. They were in great danger of falling off. To strengthen these areas, the conservators had to first vacuum or blow out the cavities before they could fill them with a special mortar. They injected a liquid stone strengthener into the porous plaster areas with medical syringes and cannulas to strengthen these areas. Following this, the conservators could start working on the surfaces: first, they focused on the loosened layers of paint, some of which stood out like clods. A liquid consolidant was then applied by using a fine brush which pressed the paint layer gently back onto the surface. The mild heat of a special heating spatula made the painting layers flexible, which helped make it easier to lay down and adhere to the upstanding clods. Special papers protected the paint clods until they firmly adhered again. The conservators spent many hours on this step, with the remains usually unseen by the viewer.

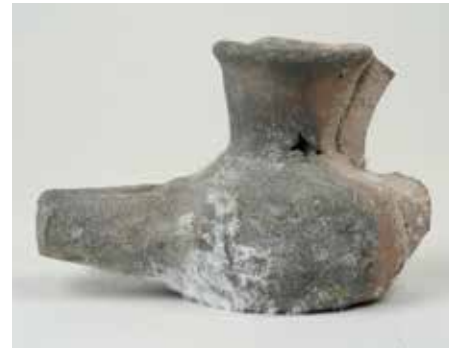
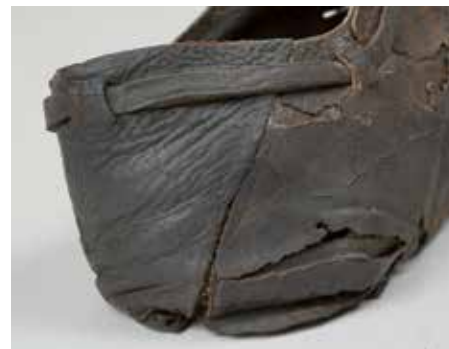
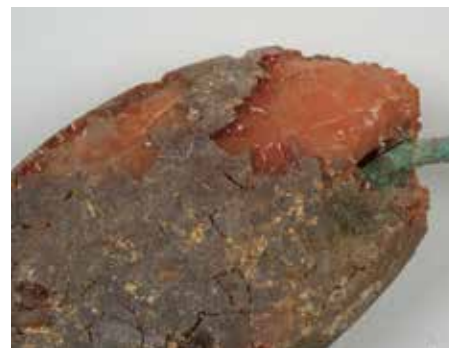
Before we turn our attention to the room, please take a look at the showcases first. The climate in museums, meaning temperature and humidity, is particularly important. The demands of different object materials on relative humidity differ greatly from one to the other. Organic materials, such as wood or textiles, require higher humidity than some inorganic materials, such as glass or metal. Objects made of ceramics or stone are comparatively less sensitive. For this reason, it is challenging to show objects with different climate requirements together in one showcase. Therefore, you will often see objects in a showcase with corresponding climate requirements. An inadequate climate can cause severe damage to the objects. To minimize the risk of permanent damage, such as cracking or flaking, conservators try to keep the temperature and humidity as constant as possible. Climate-controlled showcases fulfill this purpose, as they maintain the required humidity over a certain period and mitigate fluctuations. Equipped with a climate measuring device, conservators can monitor and, if necessary, adjust the climatic conditions in the showcases.

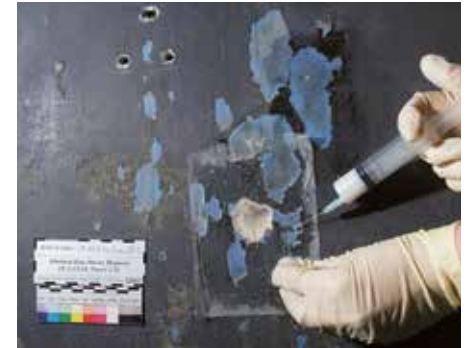
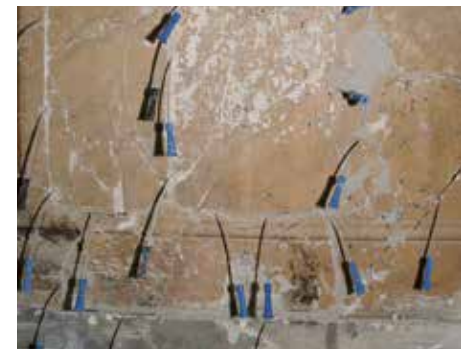
Strengthening is a fundamental conservation technique that stops or at least slows down the deterioration process of an object. Depending on the material and condition of the objects in question, conservators use different techniques and materials. Glues, resins, mortars, dispersion, or synthetic resins can be applied in many ways. By way of illustration, they can be sprayed, injected or objects can even be soaked with them.

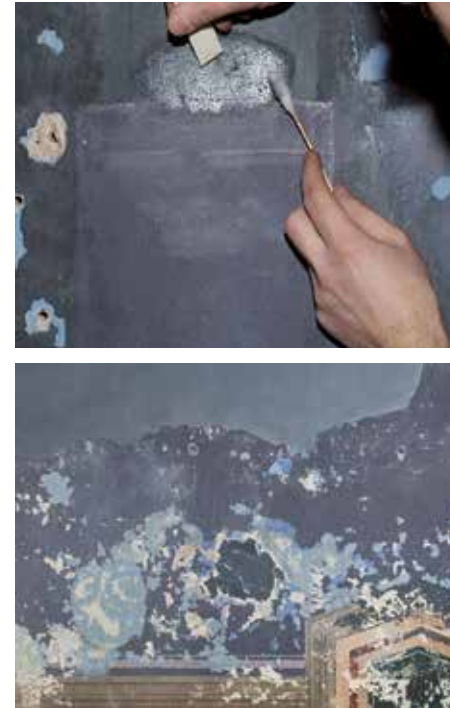
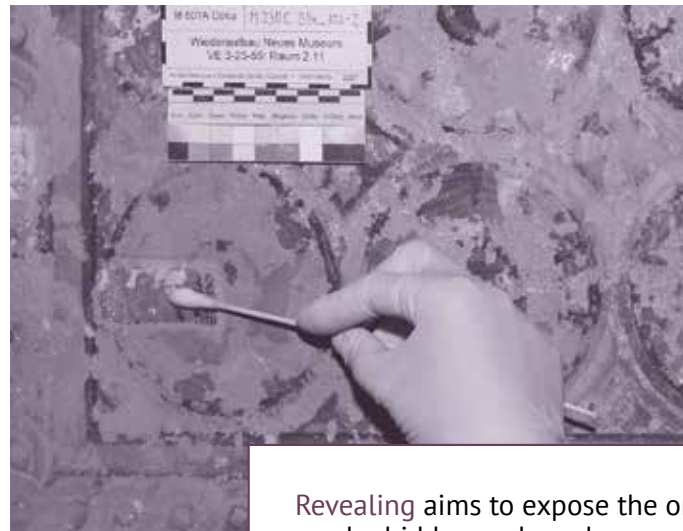
The wall surface in this room has been painted over several times in the past. In other words, there are additional layers of paint on top of the original painting, the so-called primary coating. These subsequent layers, also known as coatings, were visible simultaneously due to damage on some wall areas. The coatings in these areas were in such poor condition that it was decided to expose the primary coating. The conservators used sponges and solvents for this process. The area shown here in the brochure can be found on the wall of the window, next to the right pilaster. You can clearly see the three different blue color coatings, which originate from different times.

**Revealing** aims to expose the original surface of an object, which can be hidden under subsequently applied layers or altered by material changes. It often intends to make the original appearance of an object or the historical color or painting concept visible again. However, it can only be carried out after detailed preliminary examinations and by considering the entire context, because the removed layers would be irretrievably lost.

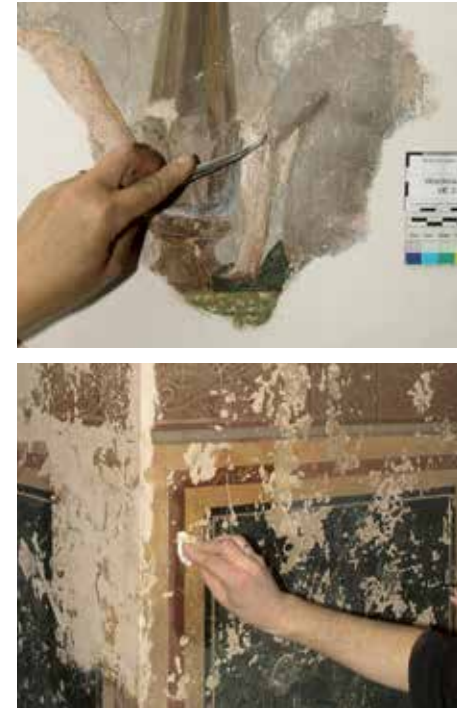
Please take a look at the painted pilasters on the window. The fact that the paintings still appear so colorful to you today is mainly due to the extensive cleaning work. Conservators used brushes, cotton swabs, and solvents to remove dirt and discoloration from the painted surfaces. As you can see in the pictures, they cleaned the surfaces with fine cotton swabs and brushes. You can see the cleaning effect on the arms and torso of the figures in the picture. On the right pilaster on the inside window side, you can see this fragment closely.

**Cleaning** is carried out not only for the sake of preservation but also for aesthetic reasons. The condition of an object or a surface can be affected or contaminated in many different ways. This is why cleaning methods and techniques are extremely diverse. They are usually tested in advance and individually adapted to the object and its material. In fact, unlike many other conservation measures, cleaning can greatly change the appearance of a surface.

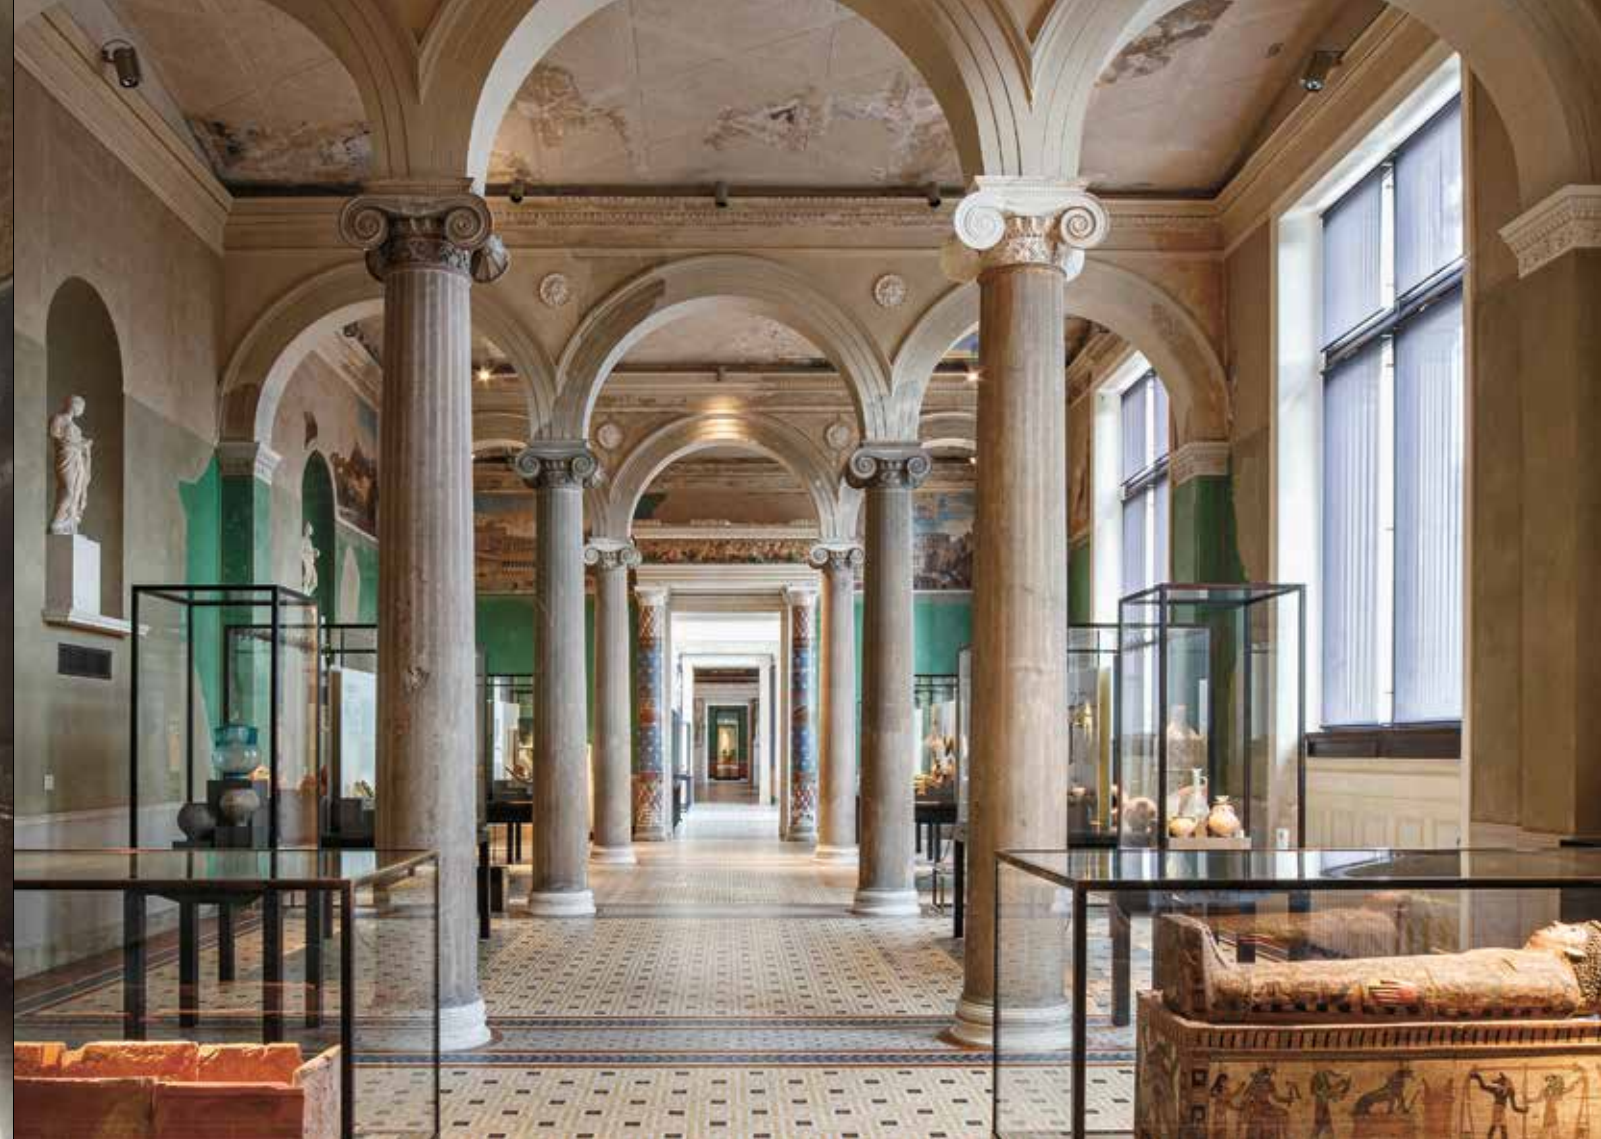
In contrast to the Bacchus Hall, the **Roman Hall** has a clear strictness and seems rather unfinished: severe damage caused by the effects of war and weathering can be seen. Nevertheless, the signs of history should not be distorted here. The fact that the extent of the former destruction still stands out today, after conservation, was achieved by the conservators

through a conservation method that is deliberately restrained. The preserved wall surfaces can be clearly distinguished: the carefully re-plastered surfaces are deliberately colored in a subtle shade of green. They appear as a restrained backdrop for the historic color scheme.

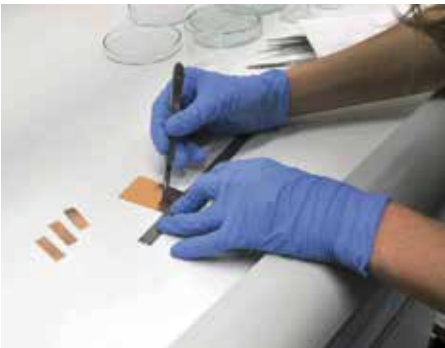
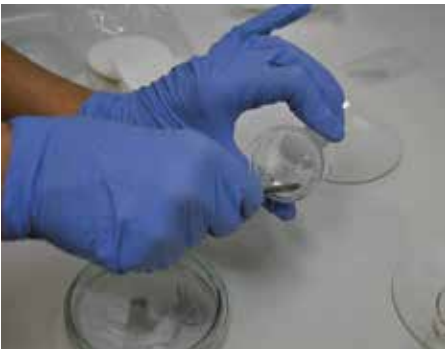
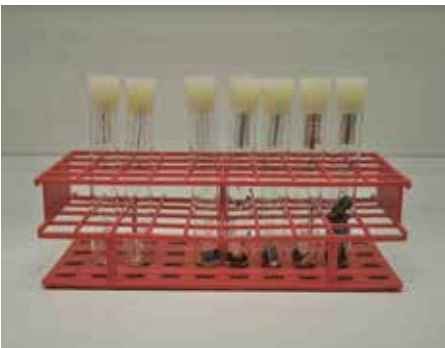
Most objects are protected in showcases. Nevertheless, objects in these small enclosed spaces can be exposed to significant risks. For example, some showcase materials that are used, such as adhesives or varnishes, can emit pollutants. When a lot of pollutants are in the air, they can harm the objects. Such damage can occur as changes in material and color. In order to achieve good air quality, conservators, therefore, attach great importance to the construction of showcases with non-hazardous materials. Therefore, modern showcases are not made from wood, as in the past, but from special metal, stone, or glass materials. The different showcase materials and modern design options can be seen throughout the museum. To test materials for their suitability for museums, conservators often use a relatively inexpensive test procedure – the so-called Oddy Test. This test, which you can see in the figures, allows them to determine whether and for how long certain materials can be used in exhibition rooms.

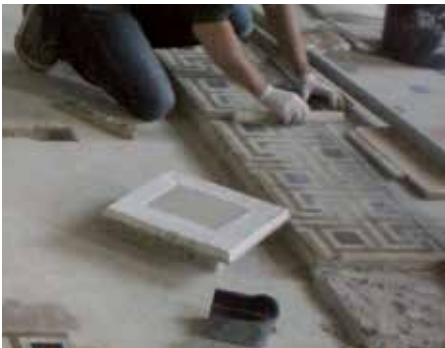
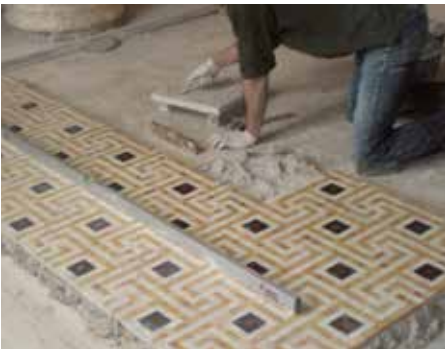
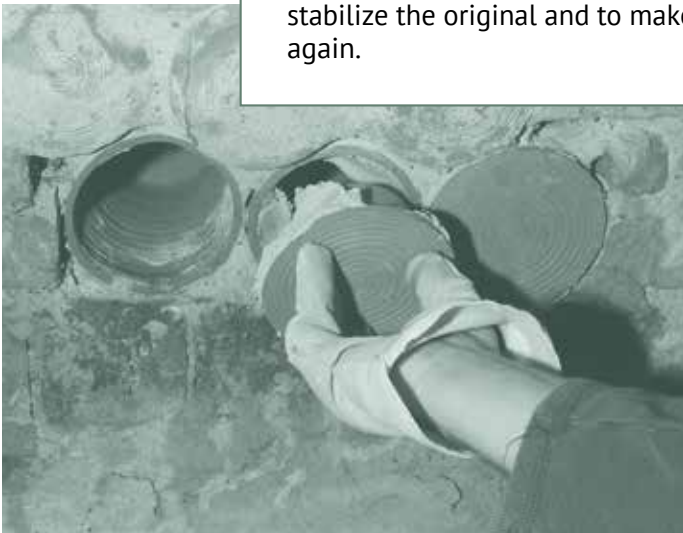
About half of the floor mosaic in this room was lost due to the war. Fortunately, many of the historic mosaic stones had survived the war in storage outside the museum and could be used for conservation. The conservators completed the smaller missing parts with the original stones according to the original pattern. For the extensive areas of missing stones, they had to make new ones from a mixture of clay, sand, and pigments. The composition of the original stones was determined using a type of X-ray examination. In order to reconstruct the destroyed areas of the mosaic, the conservators used the original installation technique: instead of laying each stone individually on the sub-floor, they made tile-like slabs out of them by using mortar and laid them accurately on the screed floor.

Both additions and reconstructions are methods of conservation that differ in the extent of their intervention. In case of an addition, conservators add missing materials to the original. The aim is to stabilize the original and to make the original's context perceptible again.

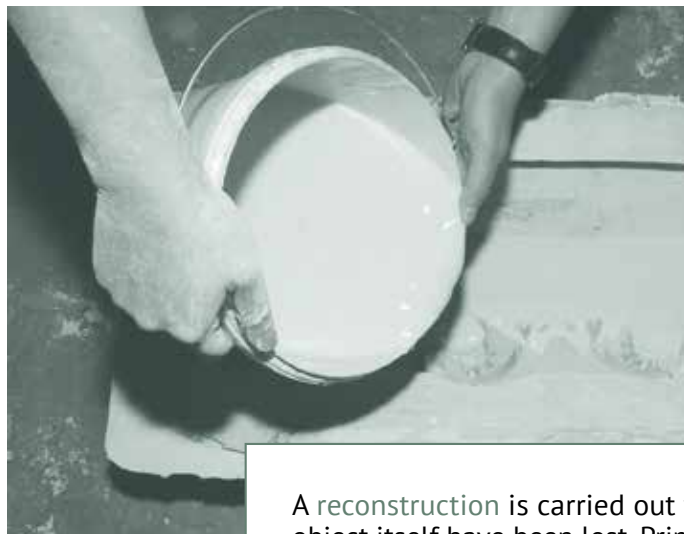
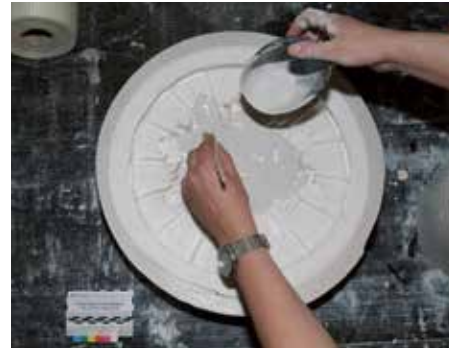
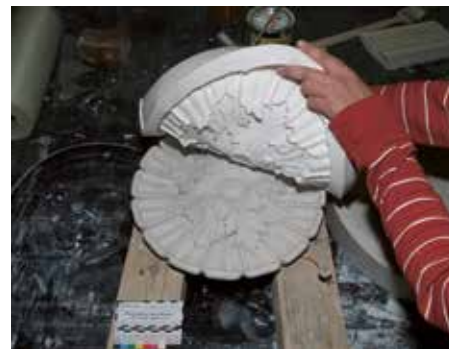
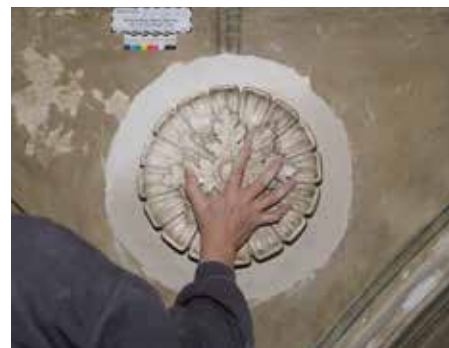
If you look up toward the ceiling at the spandrels of the round arches – that is, the triangular areas between the two arches – you can see round, flower-shaped ornaments. Only a few of these ornaments, so-called rosettes, had been maintained. Conservators were able to use them to make molds to reconstruct the lost rosettes. First, they made a negative silicone mold of an original rosette, which they filled with plaster. Once the plaster cast had dried, it could be removed from the silicone mold and returned to its original position on the wall.

A **reconstruction** is carried out when large parts or the whole object itself have been lost. Primary sources documenting the original object serve as a basis for any reconstruction or addition. Both additions and reconstructions are done in such a way that they can be distinguished from the original on closer inspection.

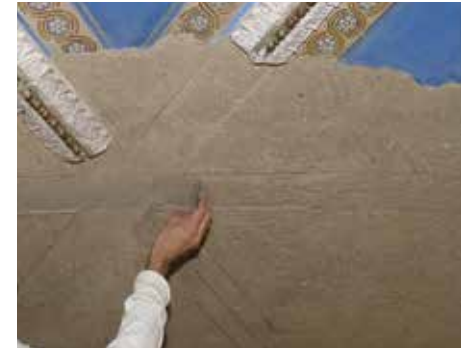
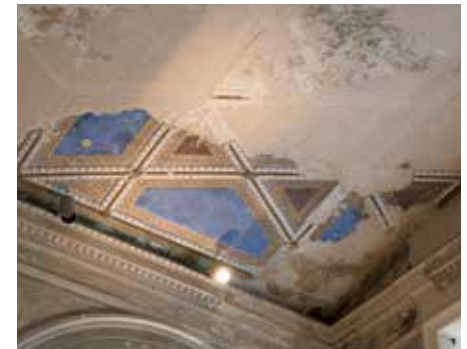
By looking at the ceiling, you can see a particularly careful type of restoration. Since such large parts of the ceiling paintings were missing, the conservators decided not to reconstruct them. Instead, they conserved the remaining original areas in form and color so that they can be preserved in their present condition. The damaged areas were filled with plaster making them appear less conspicuous and evoking a harmonized overall appearance. They indicated the geometric design of the ceiling afterward by drawing lines in the ceiling plaster corresponding to the former ceiling surfaces, which you can see in the figure. The stucco decorations and the color scheme are still missing. Therefore, the missing parts appear more balanced than before, but the extent of the damage remains visible.

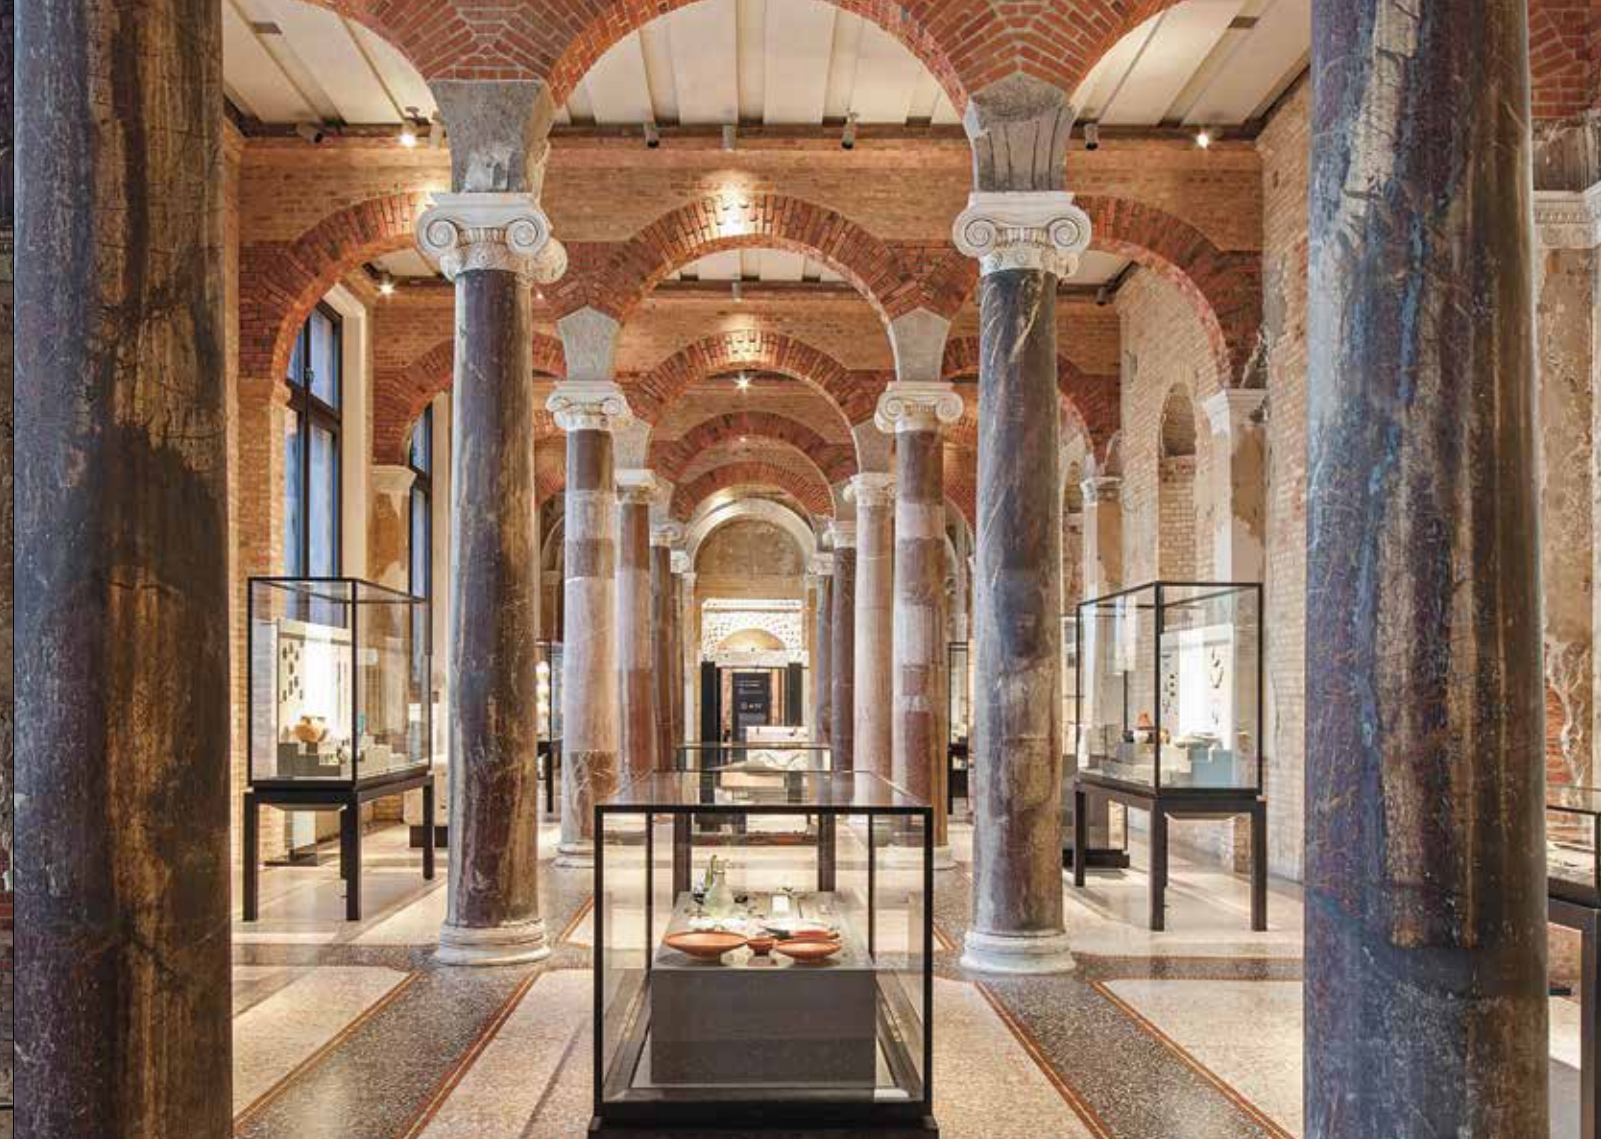
The severe destruction that the **Modern Hall** has experienced, we can still imagine today. It had lost its ceiling and large areas of the walls during the war. Unlike the Roman Hall, the basis for carrying out an addition or reconstruction was missing. The loss is also illustrated here by a strong contrast. The diverse and heterogeneous structure of the partially re-plastered

masonry and arches contrasts with the steel sheet pile ceiling, which does not conceal its modern materiality. Materiality should remain in focus during the observation: we take a closer look at some objects and their conservation here.

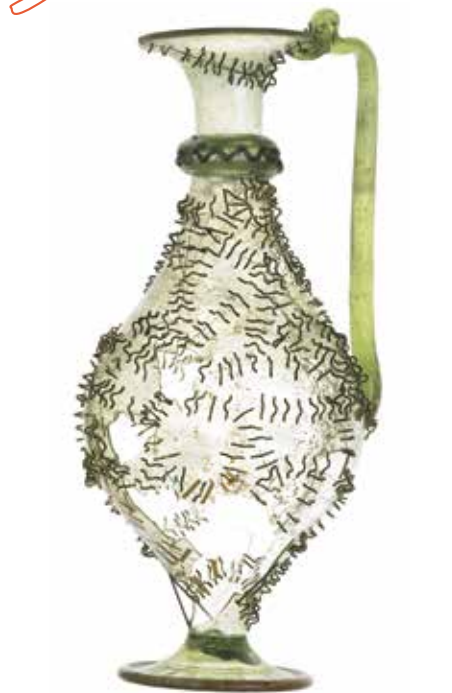
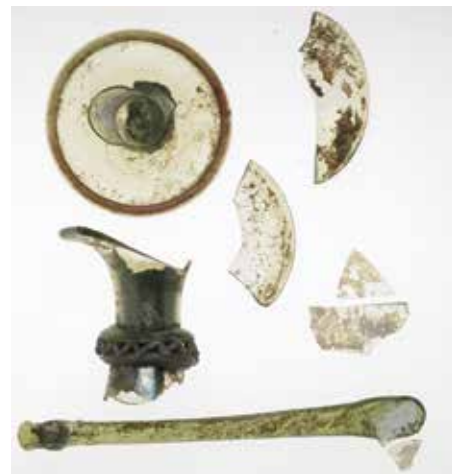
Right at the beginning, in the showcase in the center of the room, there is the late Roman glass jug shown here. Material glass preserves itself relatively well in the ground but often breaks into shards, some of which get lost.

In the figure, you can see that conservators were able to re-assemble the jug from many pieces. They stuck the pieces of glass together and added what was missing. The greatest challenge when conserving glass is not to change the original appearance of the fine material by applying adhesives. It is important to notice here that the adhesive joint fades into the background and the overall appearance is harmonized. The technique used here is called "infiltration bonding". The fragments were put together one after the other and fixed with small metal hooks. Afterward, conservators carried out the actual adhesion, after which they removed the metal hooks. The conservators made missing shards from the synthetic resin by using silicone moldings. By adding colorants, the color tone was adjusted to match the color of the glass. With the produced negative molds, the conservators were able to cast precisely fitting additions thus completing this puzzle of shards.

To reassemble shattered or broken cultural objects, conservators stick the broken pieces together. The aim is to make the object in its entirety perceptible and readable again. However, **bonding** can only be carried out if the original fragments are still there. Depending on the material and condition of the object, a wide variety of adhesives and techniques are used.

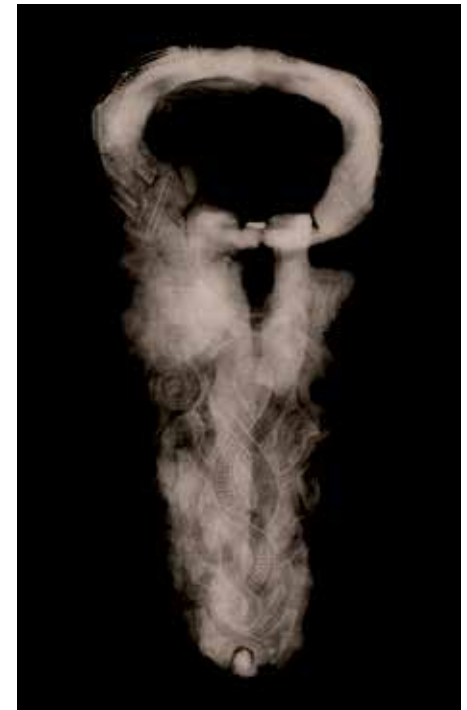
If you take a look at the showcase next to it on the window wall, you can see some richly decorated belt buckles made of iron, gold, and silver. These objects were buried under the ground for a long time. Iron is vulnerable to corrosion when in the ground. This degradation mechanism creates an orange-red layer, up to 5 cm thick, which you can see on one side of the belt buckle in the showcase. On the other side, this layer has been removed.

To ensure that conservators can get an accurate impression of the state of preservation, shape, and any manufacturing techniques of the object despite the corrosion layer, they first x-ray the iron finds. On the X-ray image shown here, you can see the metallic core under the corrosion layer as well as the decoration technique. Through such X-rays, conservators can get an impression of the object itself and they can remove the thick layer of corrosion. This process is also known as revealing or exposure. Conservators use various fine tools for this purpose, which originate from dentistry.

**X-ray examination** is a method that uses the ability of X-rays to penetrate materials. Different materials absorb X-rays to different extents. For this reason, the shape of metallic objects as well as certain manufacturing and decorating techniques made of noble metals can also be made visible under the corrosion layer.

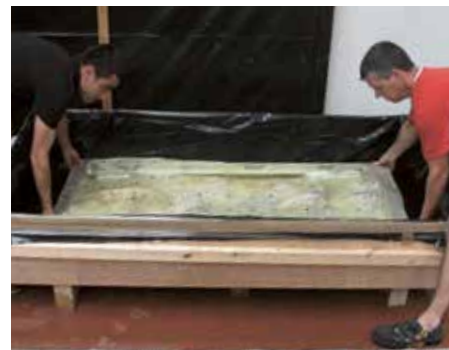
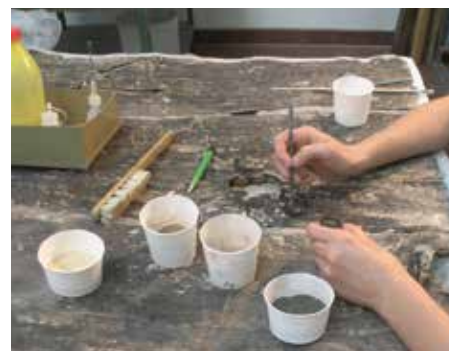
At the end of the room on the left side of the window, you can see wood discoveries in the showcase. These were found during an excavation in Berlin-Spandau. Wood is rarely preserved in soil over a long period. However, under very special conditions the organic material can survive. For example, in soils that permanently contain a lot of water and only a little oxygen, as in a bog. For this reason, such wood is damp and saturated with water. Conservators must react quickly after excavation because uncontrolled drying of wood would result in complete decay: the wood cells would collapse. Until wet wood preservation can be started, conservators keep the finds wet after excavation and keep them moist. There are different methods of wet-wood preservation. However, they all pursue the same goal: the water must be removed without damaging the object and the wood cells must be stabilized. Conservators achieve this by soaking the object in a soaking bath with a stabilizing agent. The process can take a very long time, sometimes up to several years. Afterward, the objects are gently dried, for which the conservators use controlled drying methods.

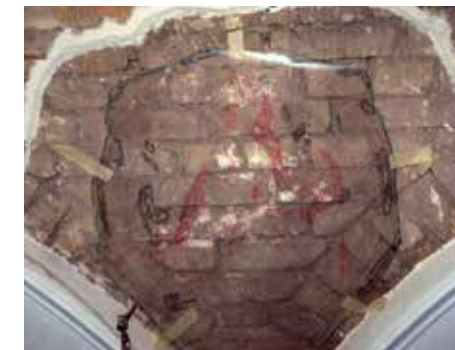
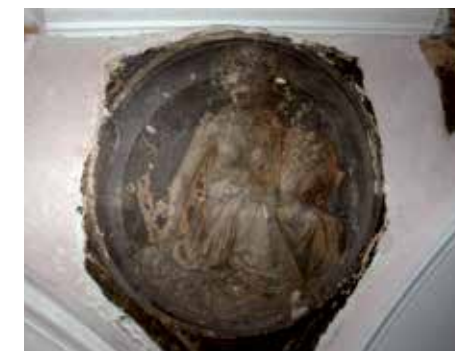
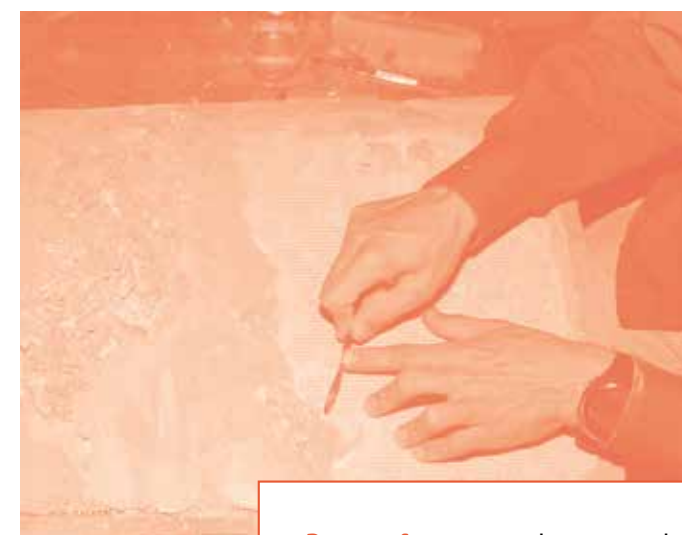
To conclude the tour, let's turn our attention once again to the building. Look at the north wall to the right wall medallion. This architectural element has received very special treatment.

It was removed from the wall in the 1980s and stored in a depository to protect it from further damage. During the conservation of the museum building, the removed medallion was treated by conservators in their workshop so it could be transferred back to its original place in the masonry. The conservators had to take precautions for the retransfer: they first secured the painting with a special protective layer to prevent further damage from the following measures. They encased the wall medallion in a supporting structure and strengthened and supplemented the old plaster. To be able to fit the medallion back into place, the conservators transferred the depiction onto a foil and used this for exact alignment on the wall. With the help of custom-made supports and anchors, they were able to return the painting to its original place.

**Retransfer** means the reattachment of art or cultural assets that were previously removed from their original location. Removing them from their original location serves to protect the art or cultural assets if they are in danger of being damaged. They are temporarily stored in a depository until they can be safely returned to their original location.
